# Manhole Inspection Summary

Manhole # S15CC2009MH

**Location** Address: **5702 RANNY RD** Cross Street: **SULGRAVE AVE**

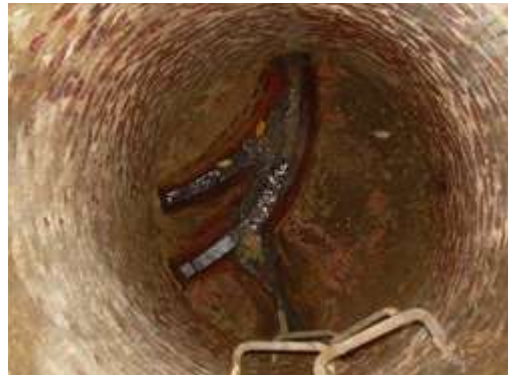
Top View

**Surcharge** ☒ **Evidence Of Surcharge** Depth: **1** (ft.) ☐ Active Surcharge Present

Evidence of surcharge - Bench debris.

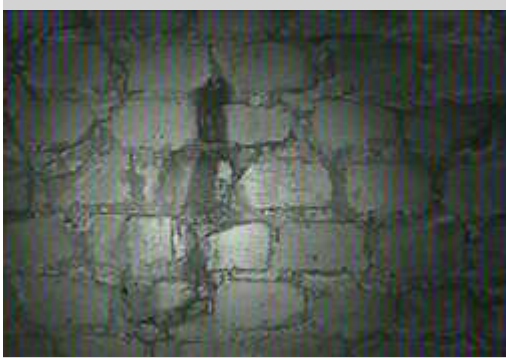
Defect

**Barrel** Material: **Brick** ☐ Parged  
Shape: **Circular** Diameter: **42** (in.) Length: (in.)  
Condition: ☐ Sound ☐ Cracked ☐ Root Intrusion ☐ Loose Brick ☒ **Deteriorated**  
Infiltration: ☐ None ☐ Joint ☐ Cracks ☒ **Mortar** ☐ Roots ☐ Wall

Barrel deterioration and infiltration.

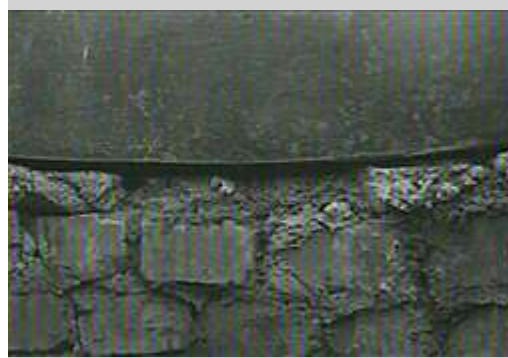
Defect

**Chimney / Frame Adjustment** ☒ Exists Material: **Brick** ☐ Parged Height: **5** (in.)  
Condition: ☐ Sound ☐ Cracked ☐ Root Intrusion ☐ Loose Brick ☒ **Deteriorated**  
Infiltration: ☐ None ☒ **Joint** ☐ Cracks ☒ **Mortar** ☐ Roots ☐ Wall

Adjustment deterioration and infiltration.

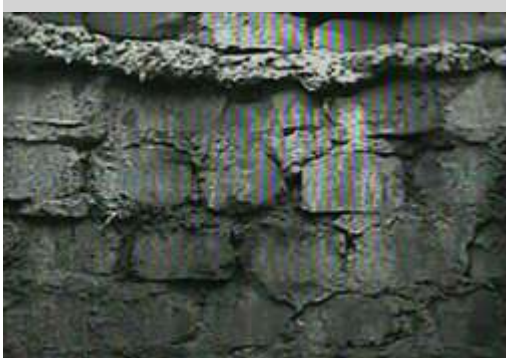
Defect

**Corbel** Material: **Brick** ☐ Parged Type: **Concentric/Eccentric**  
Condition: ☐ Sound ☐ Cracked ☐ Root Intrusion ☐ Loose Brick ☒ **Deteriorated**  
Infiltration: ☐ None ☐ Joint ☐ Cracks ☒ **Mortar** ☐ Roots ☐ Wall

Corbel deterioration and infiltration.

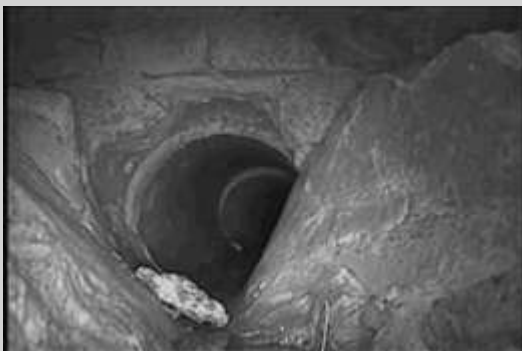
### 8 in. Circular Gravity Sewer Pipe In @ 6 O'Clock

Infiltration: **Evidence** Pipe Seal Cond: **Unknown**

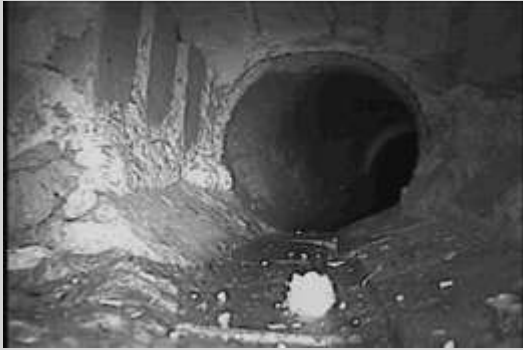
### 6 in. Circular Gravity Sewer

Infiltration: **Evidence** Pipe Seal Cond: **Unknown**
